# Qatar Islamic Archaeology and Heritage Project

End of Season Report

Spring 2013

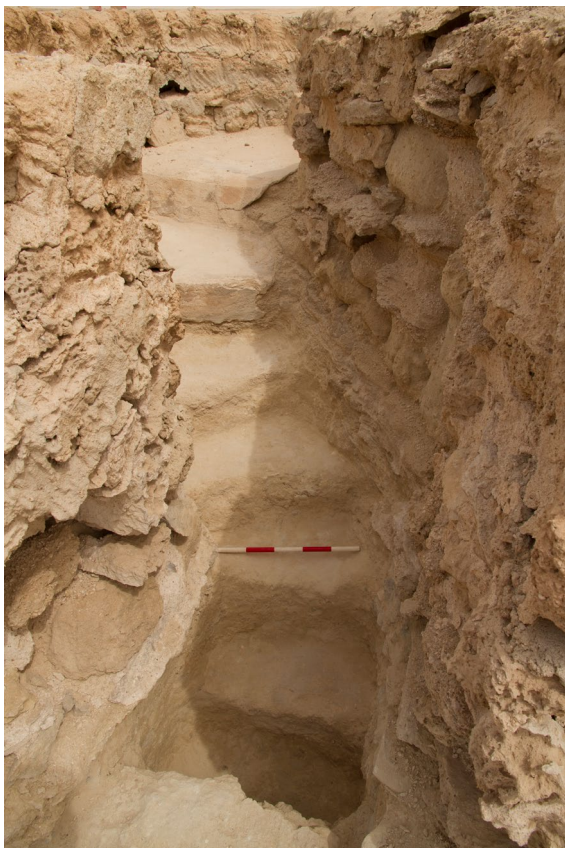
Figure 2.22: Reconstructed and original staircase within Tower 18. (HE-0153)

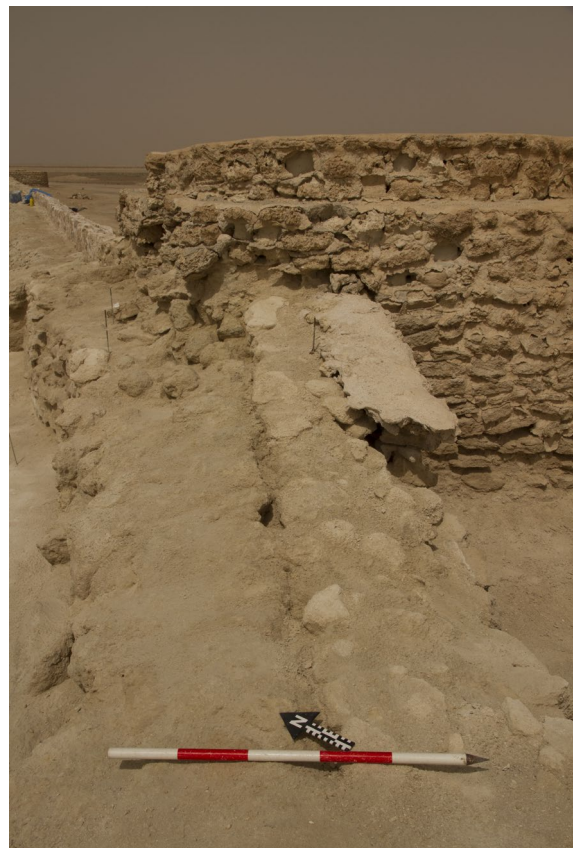
Figure 2.23: *Banquette* walkway added along inside of city wall. (HE-0130)

The addition of the *banquette* walkway likely saw an increase in activity within the surrounding area of Tower 18. This is supported by the addition of a substantial, mortar-rich laid surface which probably resulted from the spread of left-over material from a re-rendering of the walkway. Into

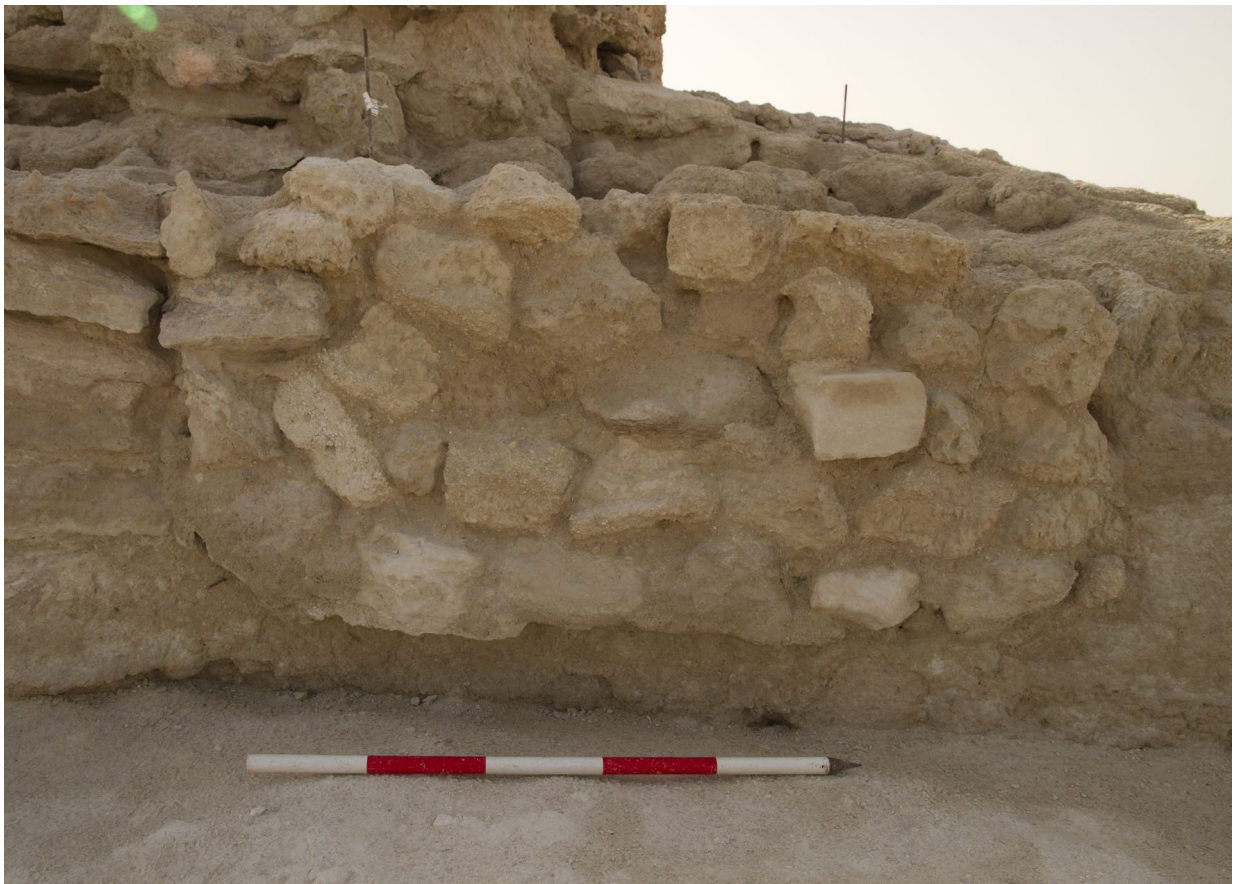
Figure 2.24: Blocking installed to restrict access to Tower 18. (HE-0137)

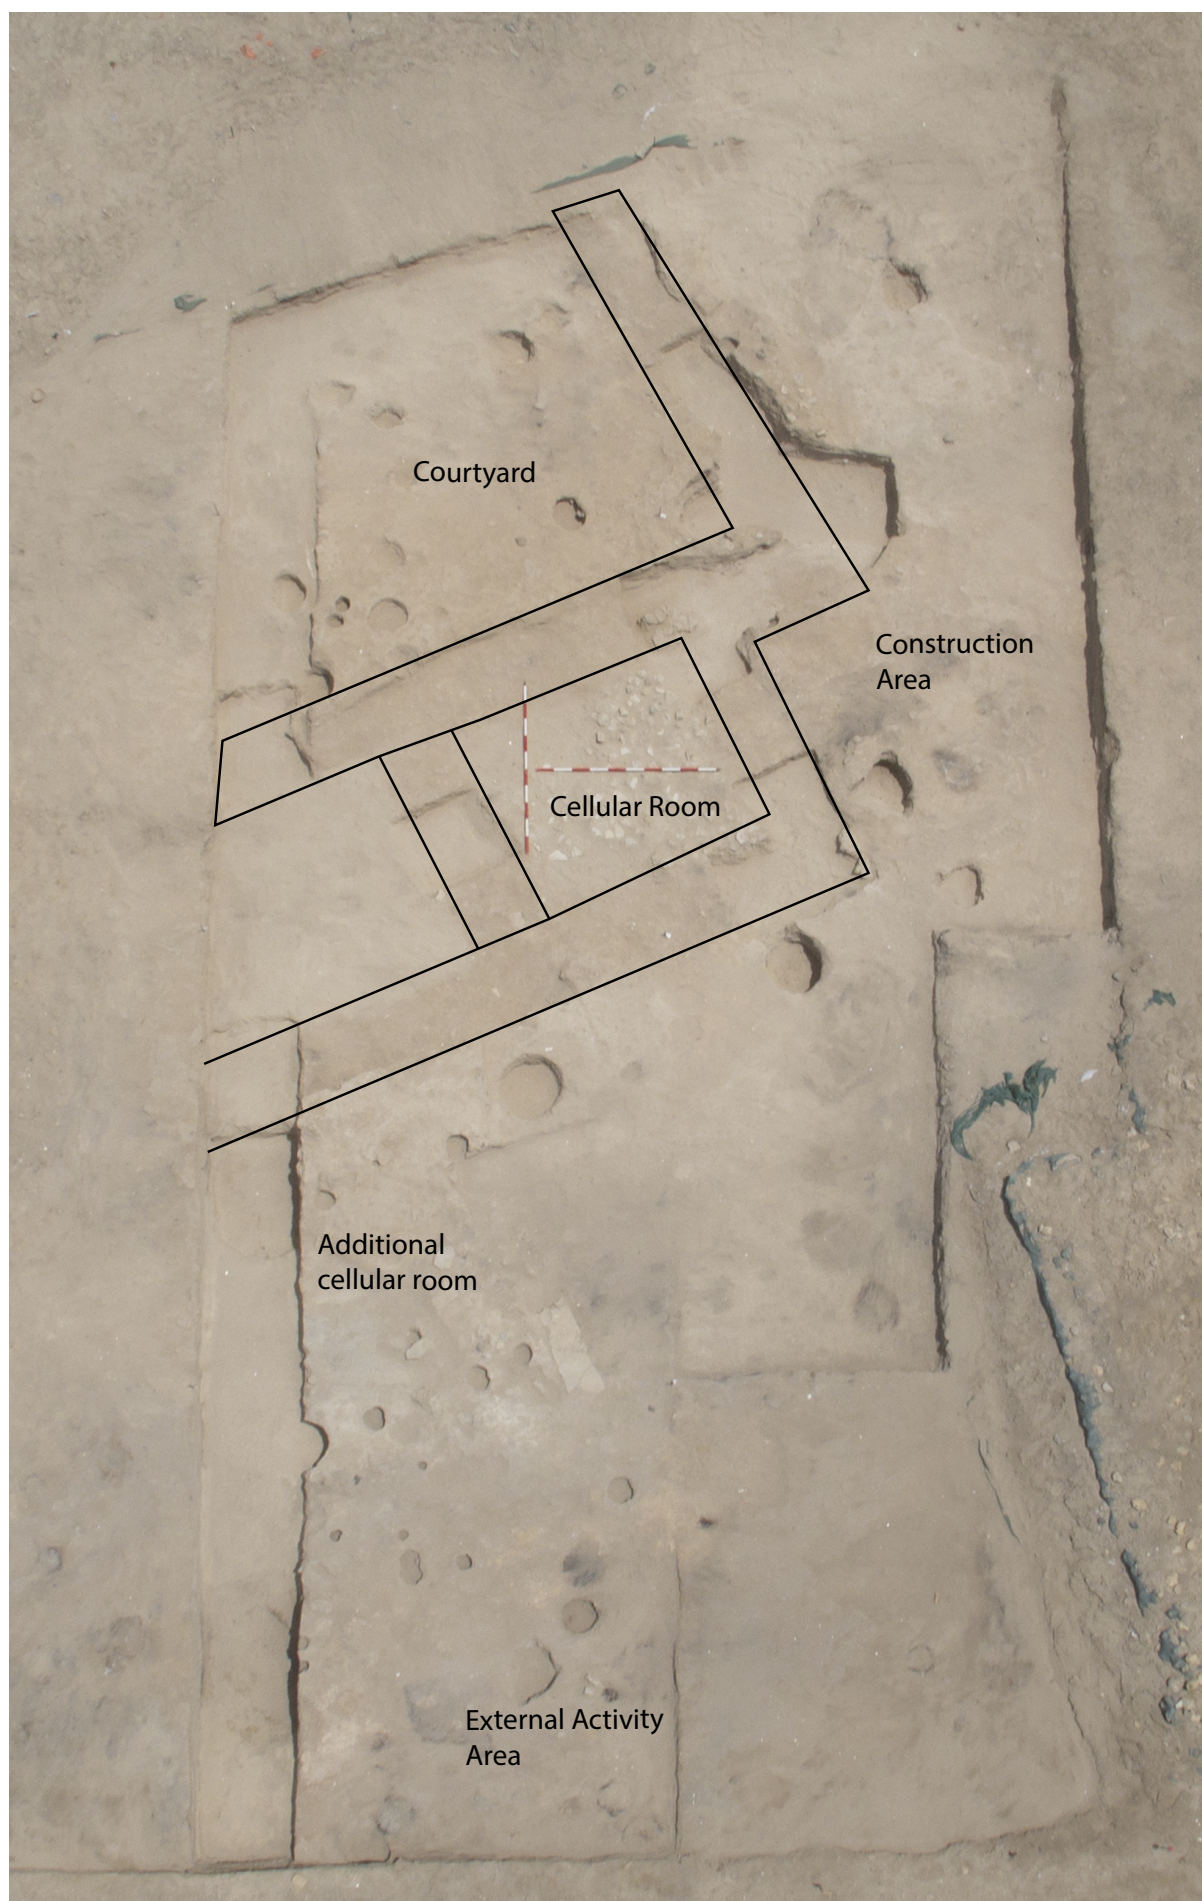
Figure 3.1: FREP04 post-excavation aerial view. North to left. (IE-0275)

Occupation and activity from Phases 5 and 6 were uncovered. The south-west corner of a large courtyard building, constructed with foundation cuts, was uncovered in Phase 6. This was associated with domestic activity in the courtyard and externally to the south and west (Figure 3.1).

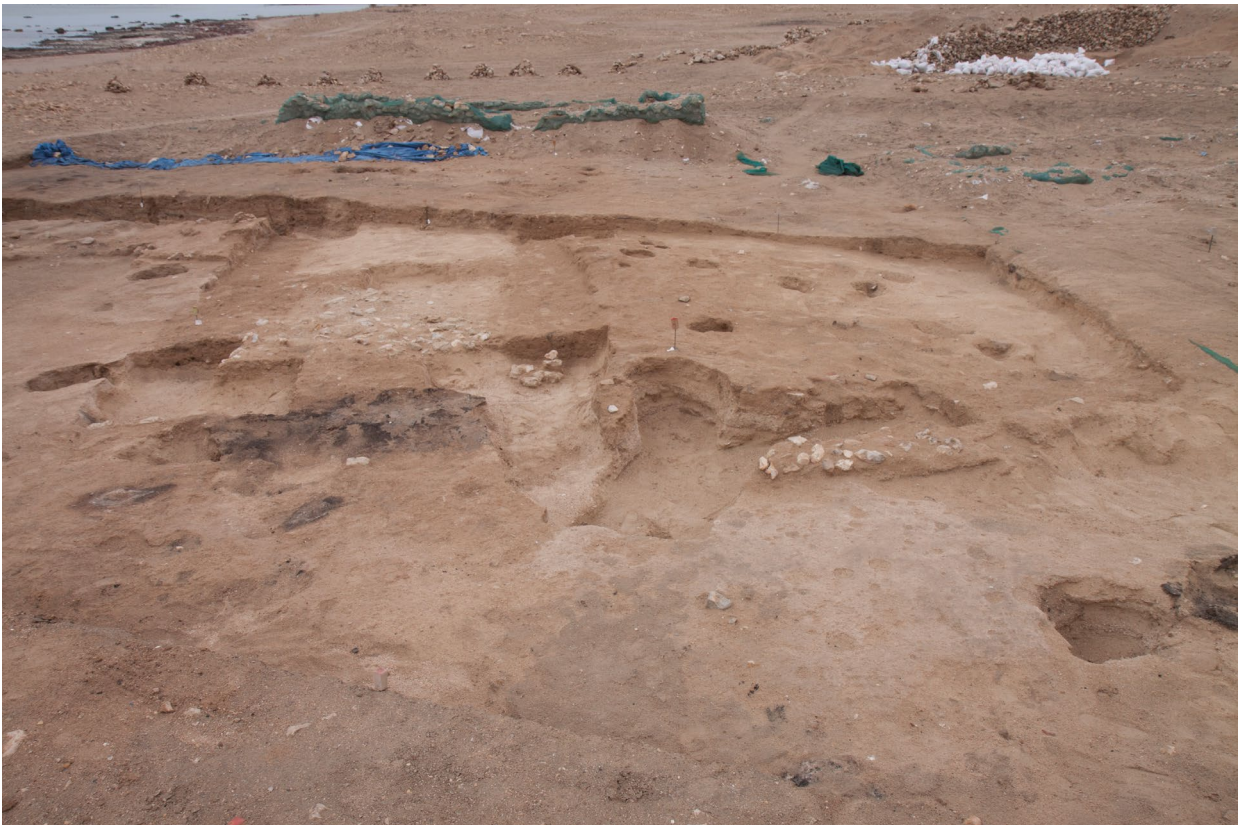
Figure 3.2: Construction area: Burnt (left) and compacted anhydrite (right). Facing north- north-west. (CE-0202)

The first activity uncovered in this area was associated with the initial construction of the building. A large spread of ash and charcoal was overlain by a thick layer of burnt anhydrite rock located adjacent to the southern foundation trench of the building. The heating of anhydrite to make mortar for construction was common in all phases of activity in this area (Rees 2012). Located directly to the east of the anhydrite heating zone was an area of compacted anhydrite mortar, previously thought to have been a surface (Figure 3.2). Given its proximity to the burnt area, it is likely that this deposit was formed due to lime-slaking, where water is added to heated rock to form a fine mortar that can be used in construction. Several other fire pits and small pits with mortar residue also appear to be associated with this initial construction phase. The mortar may have been used as a bond in the walls as well as a lime-wash or plaster, none of which survived *in situ*.

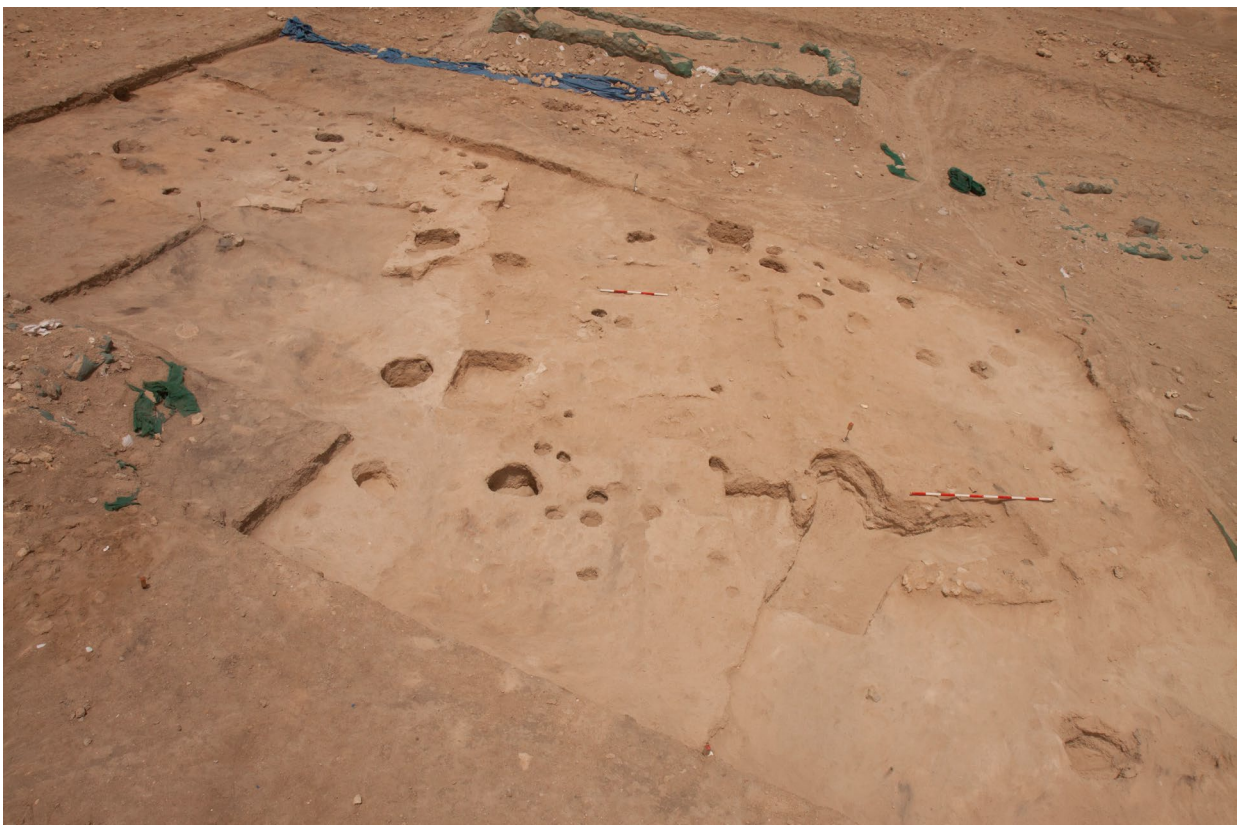
Figure 3.3: Foundation trench with fill. Facing north-north-west. Scales to the north of the cellular room (left) and adjacent to courtyard wall foundation (right). (CE-0152)

the lower courses of these walls would have been made of stone, whilst a clayey-silt built-up, interpreted as mud-rubble, around the foundation trenches is indicative of a mudbrick or pisé wall above. This mud-rubble tended to have a vertical edge on the side facing into the structure, spreading out into a thin wedge – a formation that is likely to have occurred when mudbrick collapsed from the walls and built up against the masonry below. The internal wall edge could be seen in the cellular room where the surface would have abutted it.

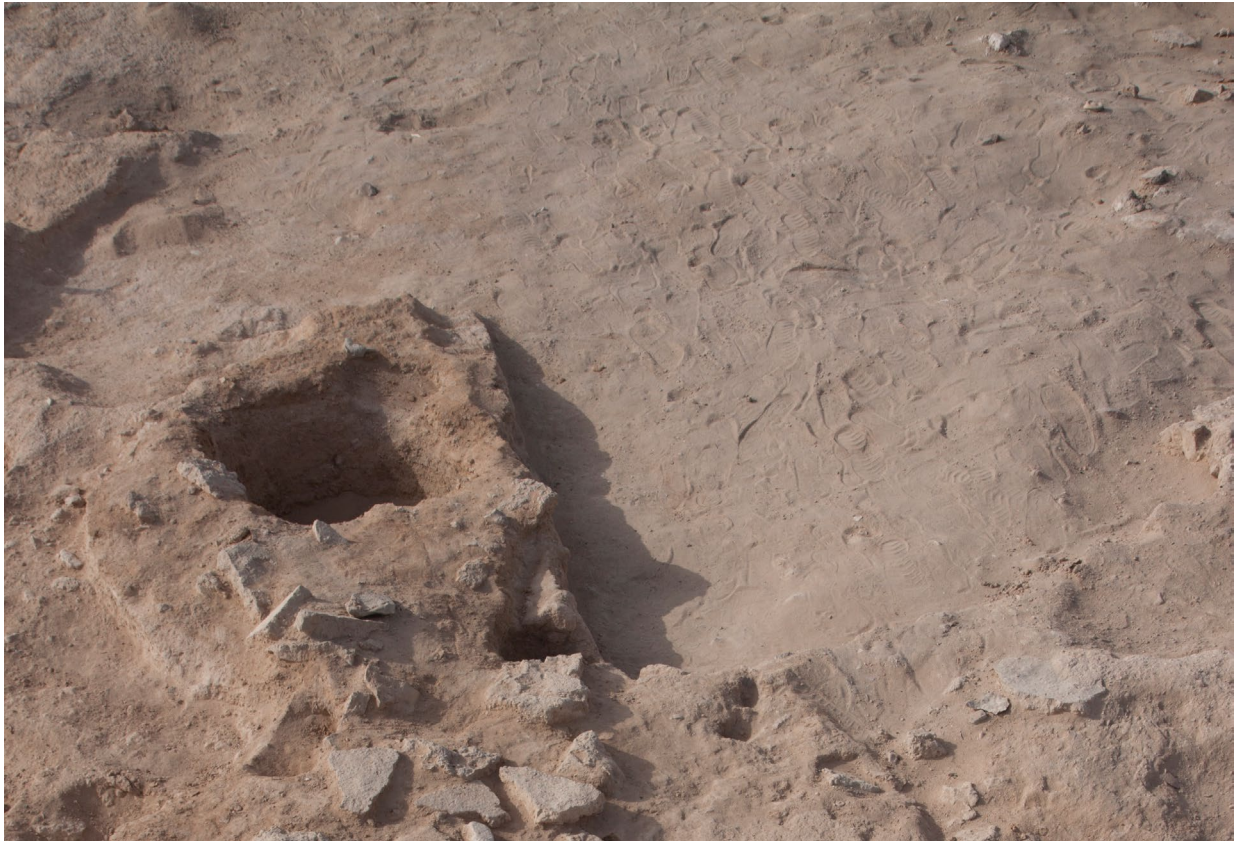
Figure 3.5: Interleaved layers of rubble and mudbrick collapse over western wall. Facing south. (CE-0124)

There were several indicators that the courtyard building was in use for a relatively long period of time. The addition of the western room, built over deposits abutting the original wall, suggests an intention to expand the existing building. Multiple re-surfacing events around the outside of the building to the south and west, and inter-leaved layers of mudbrick erosional deposits and surfaces in the courtyard indicate that buildings and spaces were being repaired rather than abandoned (Figure 3.5).

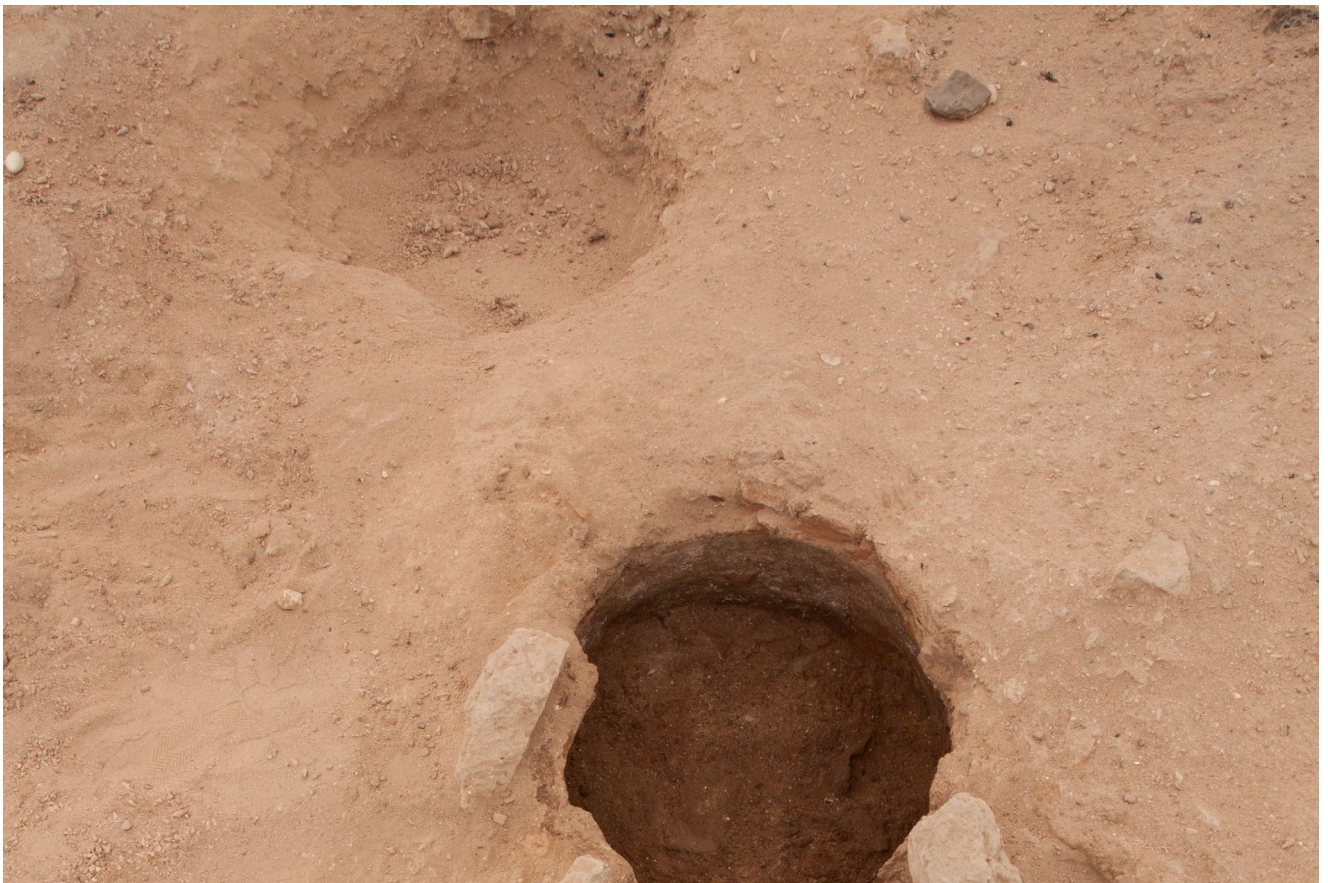
Figure 3.6: *Tannur* in courtyard with beachstone opening. Facing south-east. (CE-0048)

Two of the *tannurs* in particular were of note because they preserved components that did not survive in similar features. These *tannurs* had beach-stone slabs placed on end at the north-western side of the cut; the clay linings were then built up to this level, creating a platform with a funnel facing the prevailing wind (Figure 3.6). These stone funnels may have been used to control air flow and temperature as well as to add more fuel.

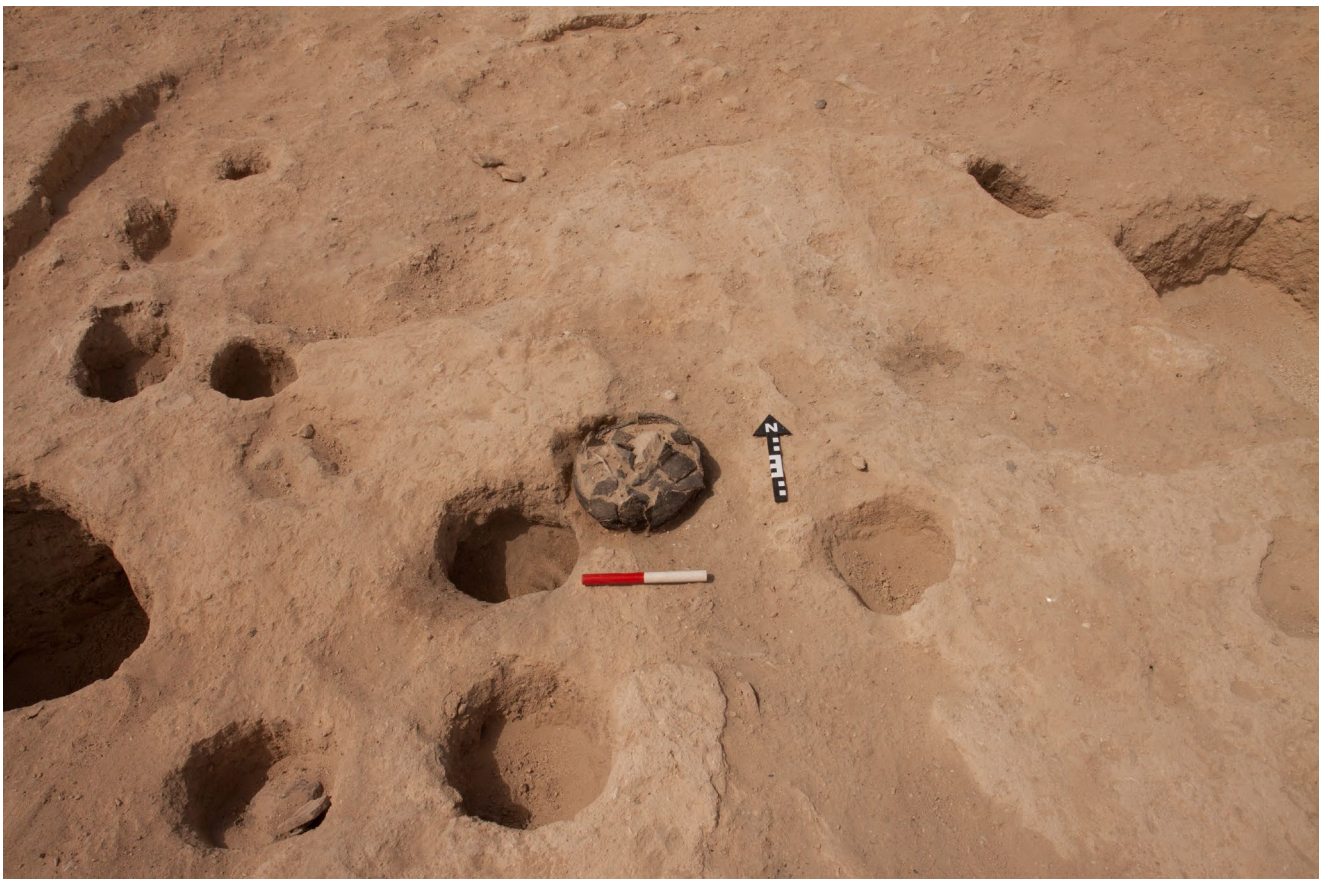
Figure 3.7: Fire pits showing final location of temporary ceramic lining. Facing north. (CE-0034)

There were two periods of activity to the south and west of the building. This activity was primarily evidenced by compacted sand and shell surfaces. The first surface covered the area where construction activities had taken place. This surface contained two *tannurs*, seven fire pits and a large deep pit that may have contained a water storage vessel. The fire pits, all of roughly similar dimensions, were located in an area to the south of the building. One of these contained an *in situ* re-used ceramic vessel which may have been moved from pit to pit, creating a temporary oven lining for each use (Figure 3.7). Sand and midden material built up over this primary surface before the second surface was laid. This was associated with a large number of post holes, particularly to the west, which may have been part of a temporary structure in this area.

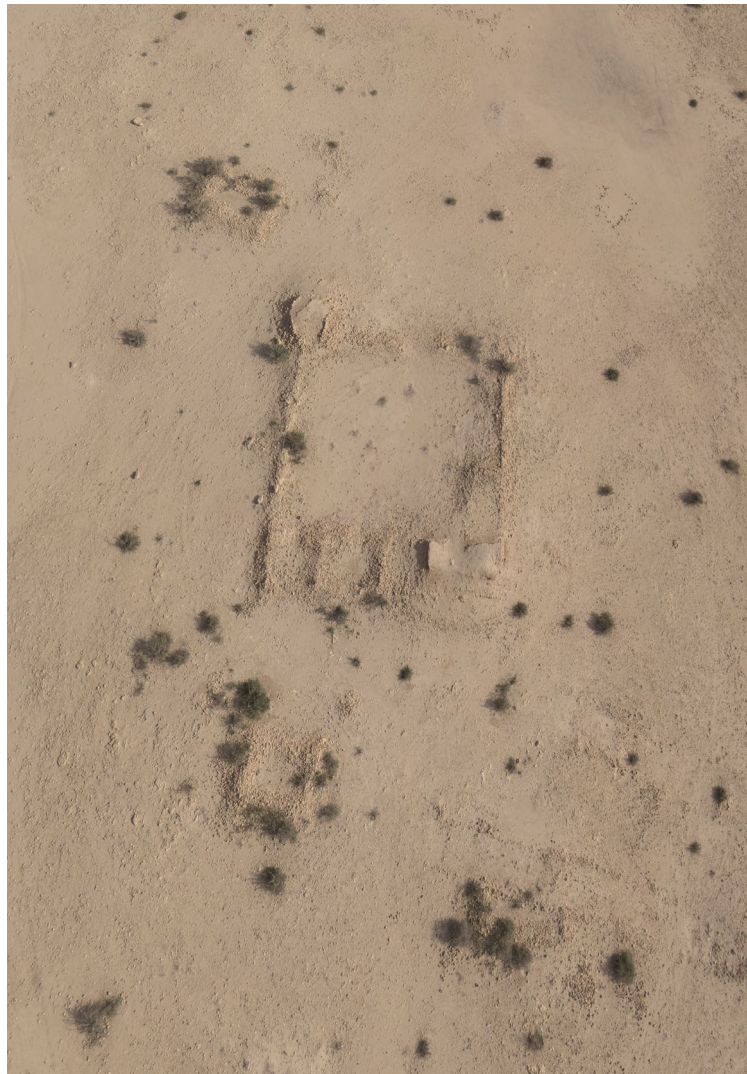
Figure 4.2: Qal'at Shuwail, the fort and nearby settlement features (SAC-0054 - 0058)

This site is situated c.1.1km east of Al Zubarah Fort and is comprised of a small, ruined fort (QNHER 10320) on a raised area of lithosol within a large irregular area of *rawdha*. Surrounding the fort, along the edges of the *rawdha*, are several groups of dispersed ruined stone and pisé structures (QNHER 10321, QNHER 3670 and QNHER 10325) and a series of wells.

The site was briefly mentioned as a fort contemporary with Al Zubarah in 1850, and surface pottery collected at the site generally suggest an 18<sup>th</sup> century date. Shuwail may have played a

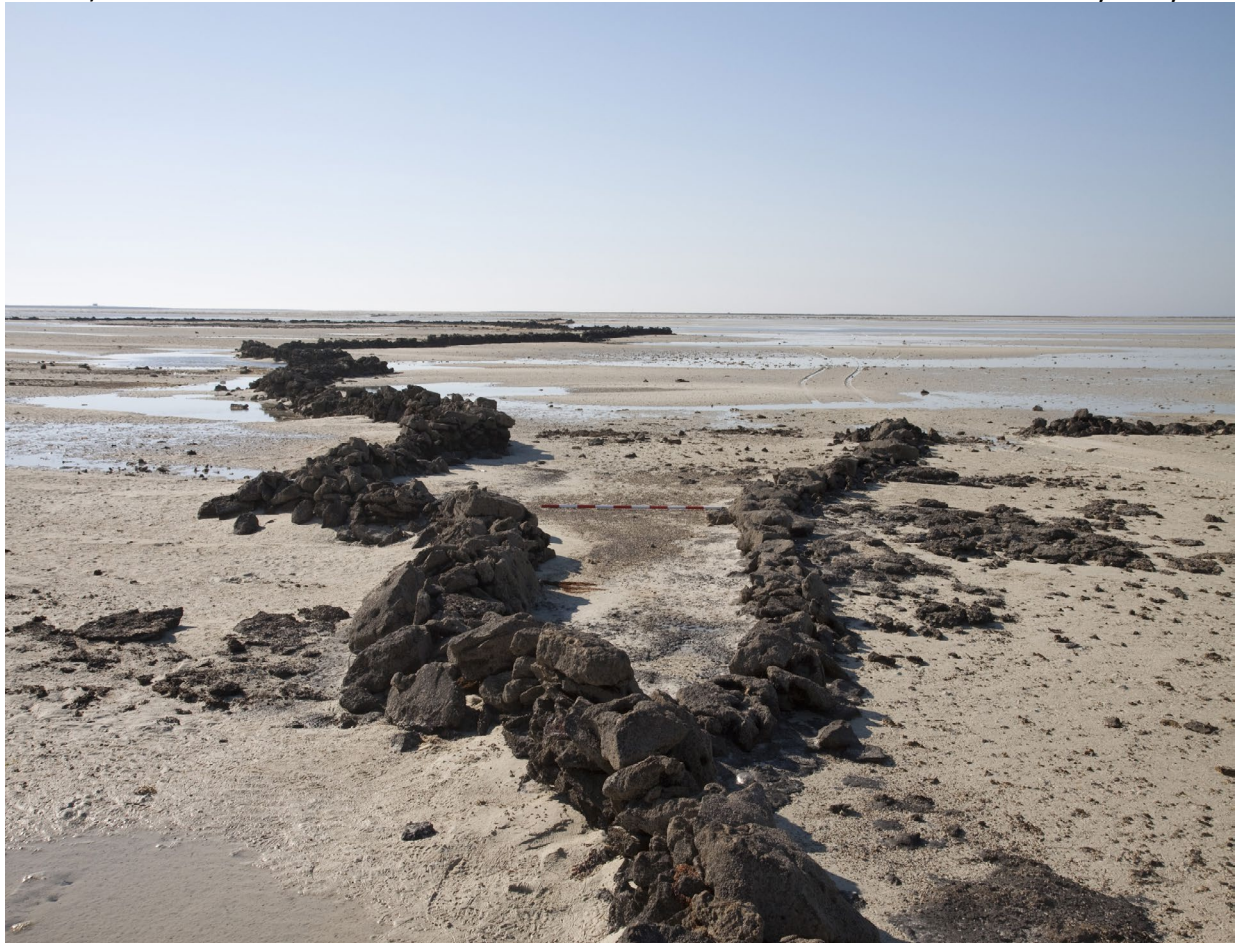
Figure 4.3: Fish Trap QNHER 10174 (SAB-0097).

There are five intertidal fish trap systems around the coast within the Buffer Zone. They are comprised of stone walls that form long arcs along the coastline. They occur close to coastal settlements as in the case of the two southern systems (QNHER 10268 and QNHER 10269) on the Ras 'Ushayriq peninsula. Another small system (QNHER 10213) runs north-east from the promontory to the north of Al Zubarah. Finally, two traps (QNHER 10173 and QNHER 10174) were recorded to the west and south-west of the former settlement destroyed by the

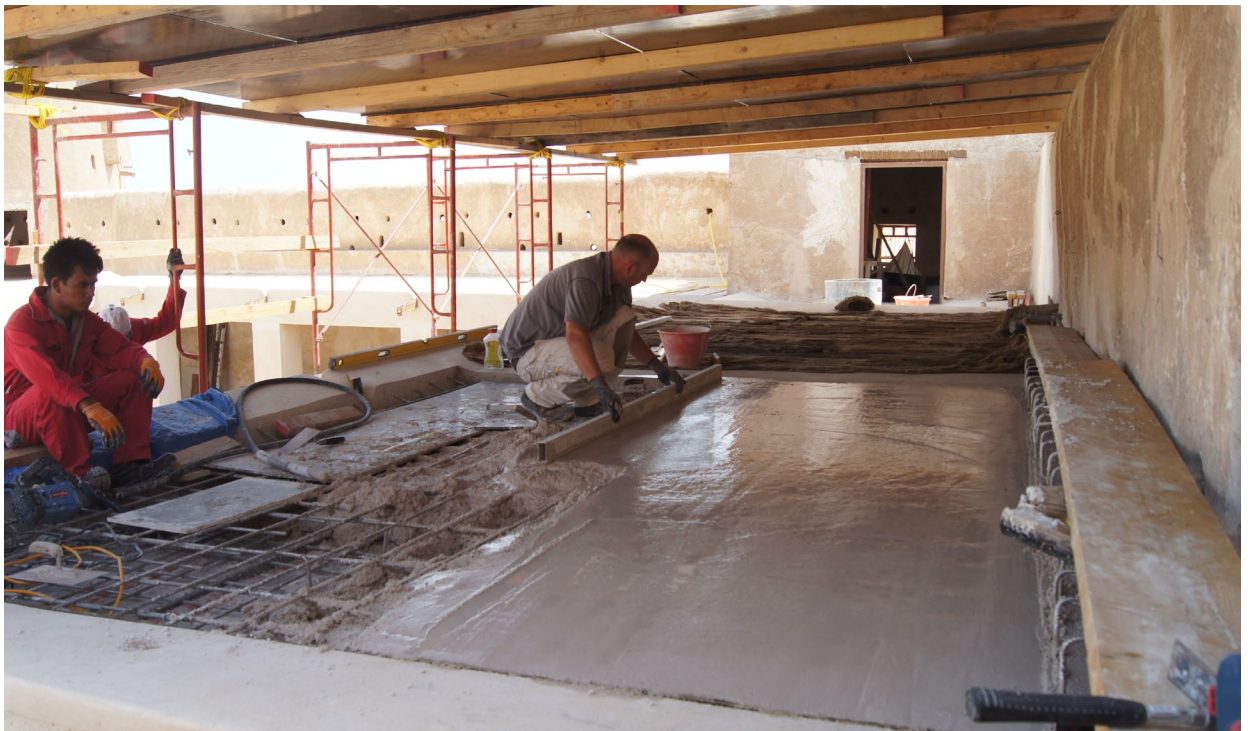
Figure 7.1: Roof of the southern wing being inserted. (ZUXE-0342)

It was initially intended to keep the earthen roof and to find ways either to retrofit it or to redo it entirely in an optimized way. However, it became obvious that this approach would not lead

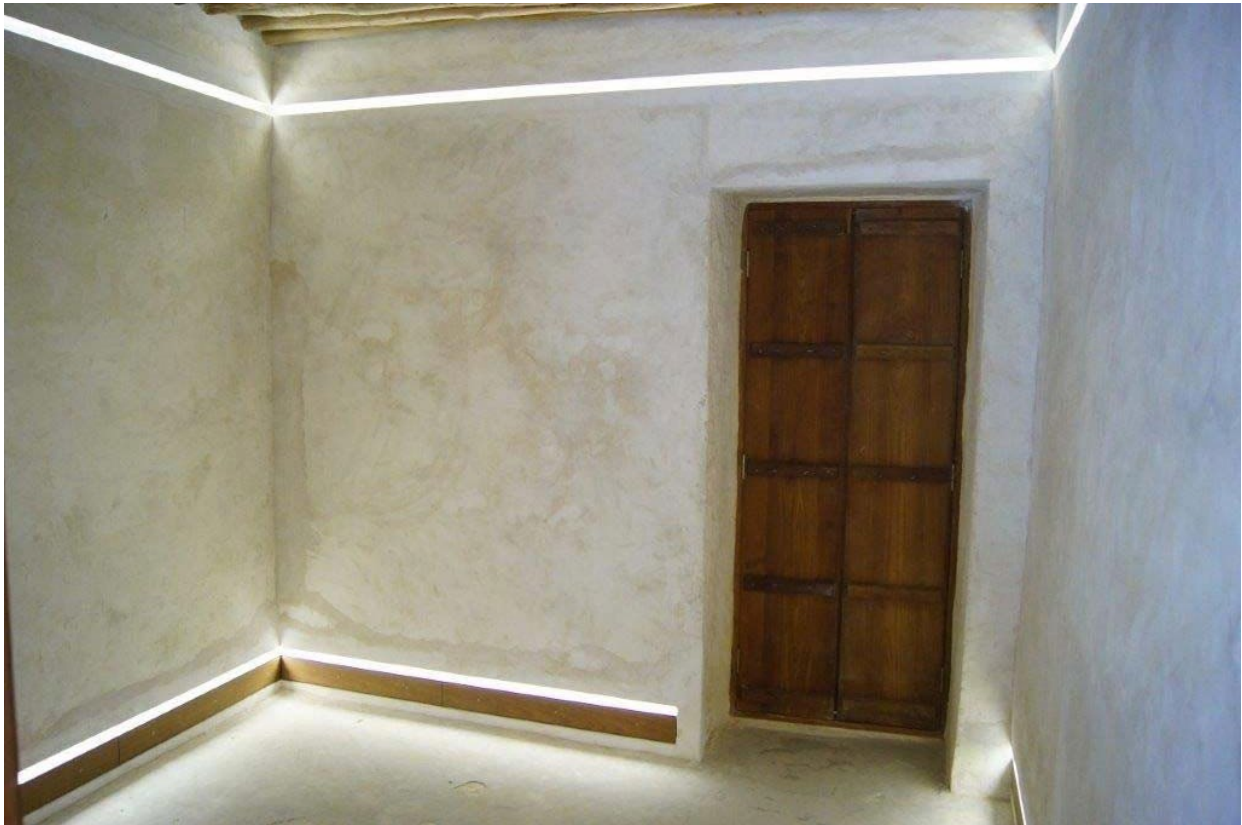
Figure 7.2: Electrical installation and light rails in the interior of the fort.

Parallel to these works the electrical lighting system for the rooms of the fort needed to be installed. This was designed to consist of LED light rails inserted into metal profiles providing indirect light to the rooms. At the end of the season the entire lighting system and the electrical installation was finished and ready to work. Until the connection to a mains electricity supply, the fort lighting is powered by a generator (Figure 7.2).

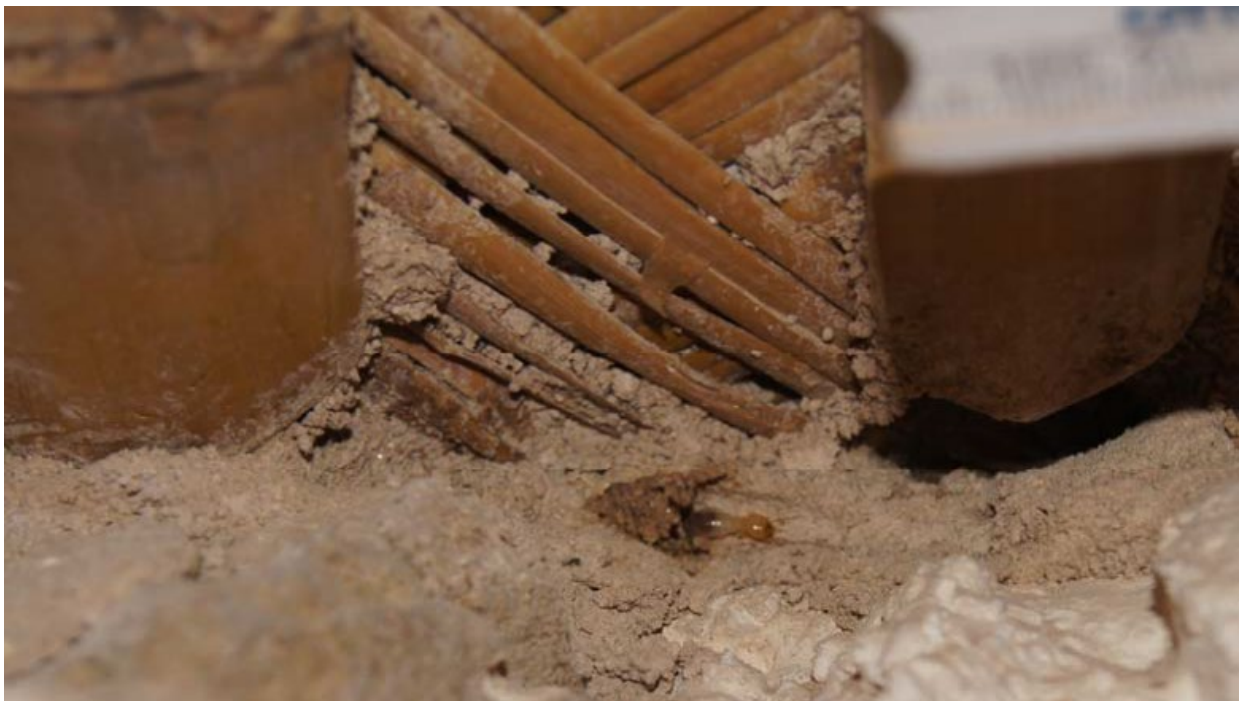
Figure 7.3: Termite infestation underneath the ceiling in the fort.

This documentation allowed the structured long-term observation of issues such as termite infestation, which was initially encountered in 2012 and was described as one of the major factors weakening timbers in the structure (Figure 7.3). Specimens of the insects were collected for species identification at the Federal Institute for Material Research (BAM) and the Thünen-Institut of Wood Research in Hamburg. The observations showed heavy infestation in two areas of the fort, but concentrated on the *danshal* joists as well as the matting. The termites live in underground colonies and can move freely within the walls. Continuous monitoring and control of termite infestations by repellent or termiticide are essential to ensure the longevity of the fort restorations.
